MPL PARTICIPATION IN SEALAB II

1 FEBRUARY 1966

SIO REFERENCE 66-3

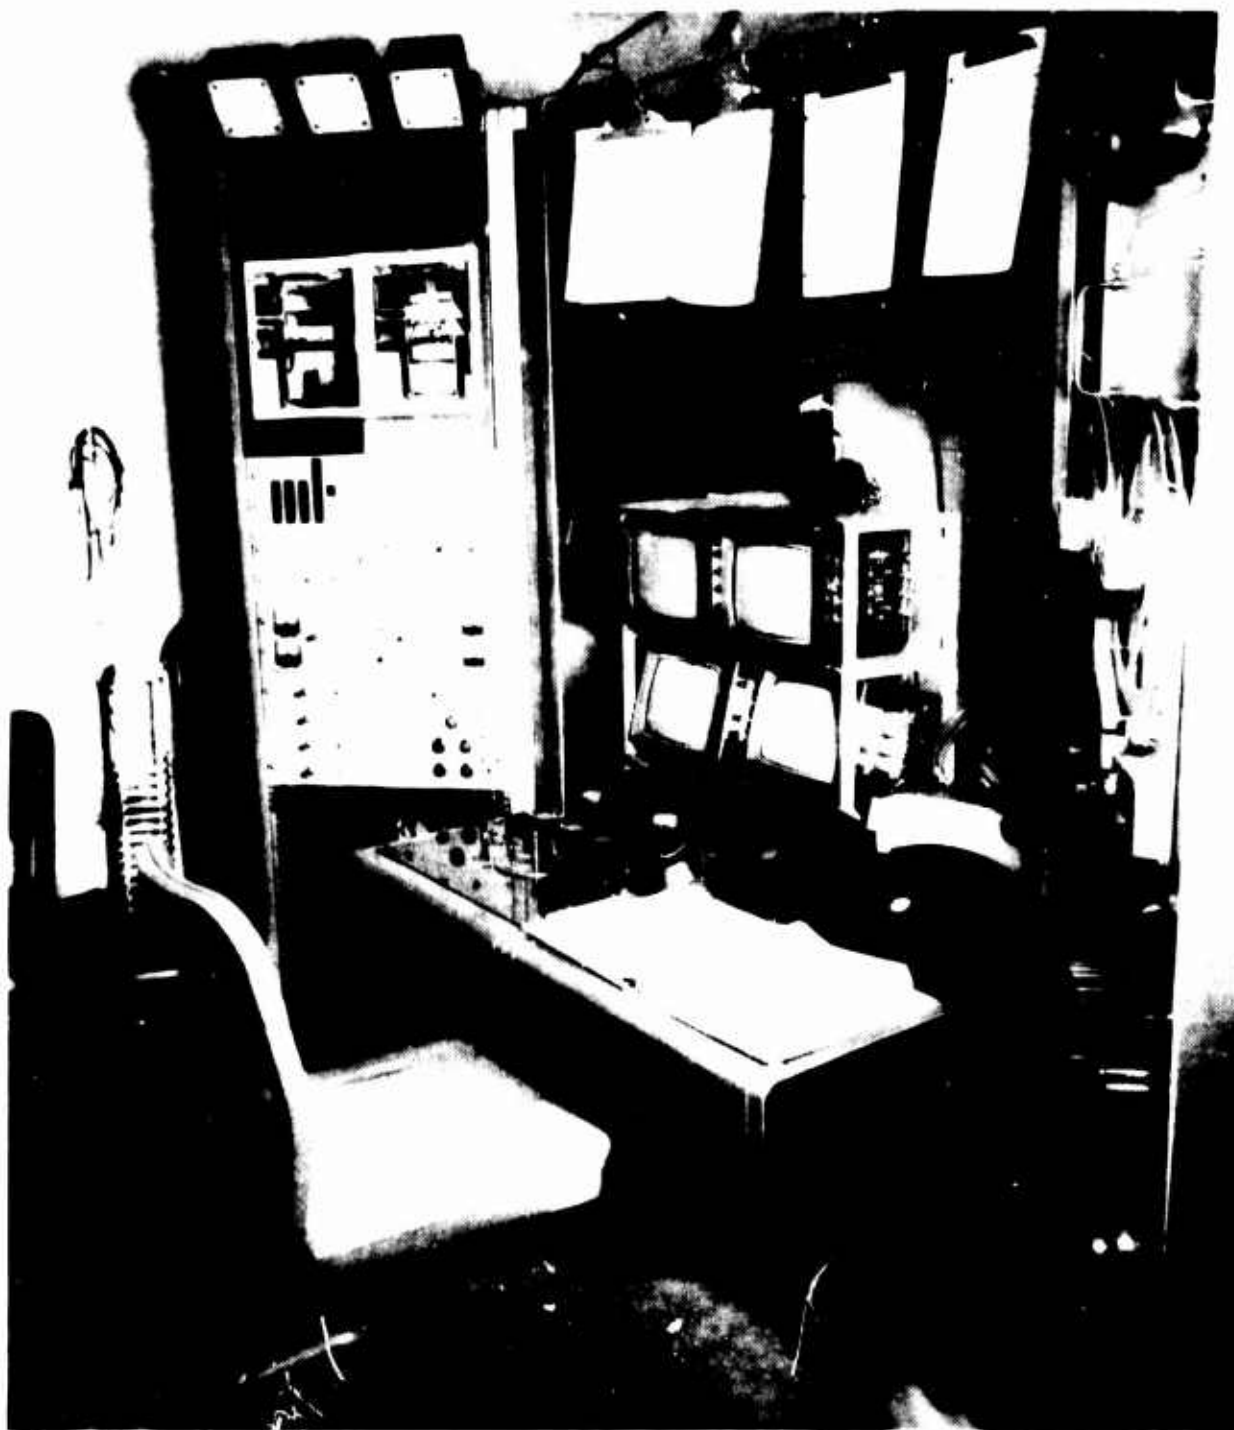
Figure 8b. Operator's console

In considering the above items it is interesting to note that: (1) Corrosion was also evident on the *SEALAB* rack-mounted connectors (see Figure 8b), and (2) the single connector associated with the communications cable, which is terminated only by floating transformer windings, showed no signs of deterioration.

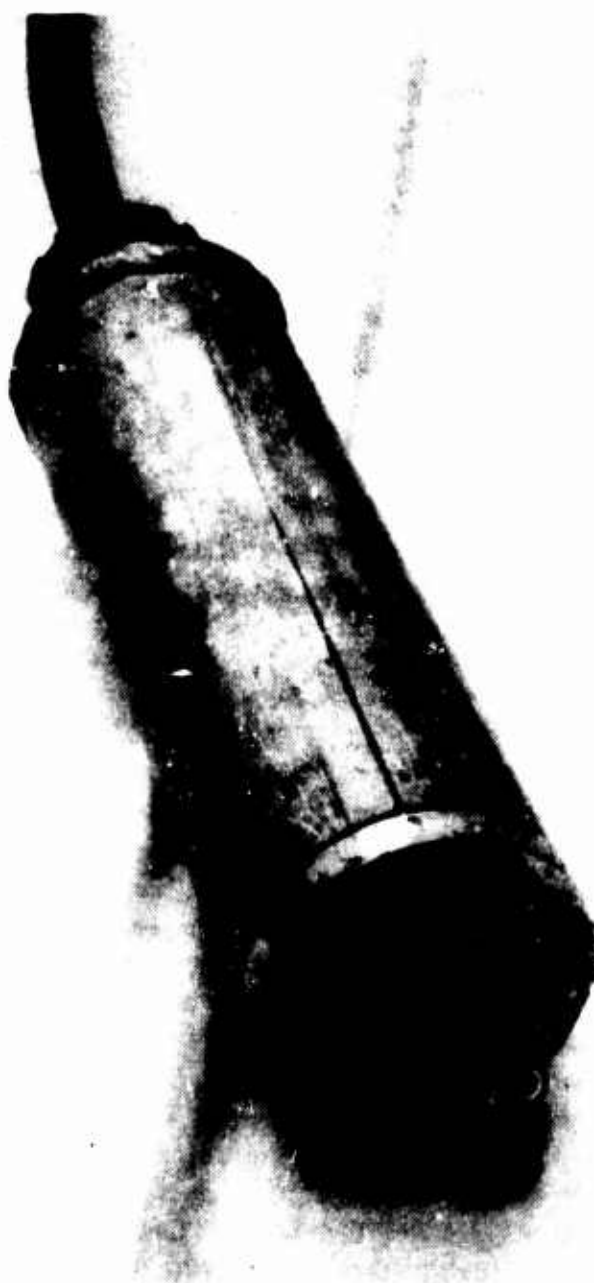
Installation procedures called for the marriage of Benthic Lab to *SEALAB* to be made underwater. Consequently, small pressure cannisters were fabricated to seal and protect the *SEALAB* end of each cable. Each cannister was filled with alcohol to prevent sea water contamination (alcohol being a fluid compatible with the *SEALAB* atmosphere). Figure 13 shows the pressure case for the 50-conductor communications cable.

Figure 13. Pressure case for communications cable

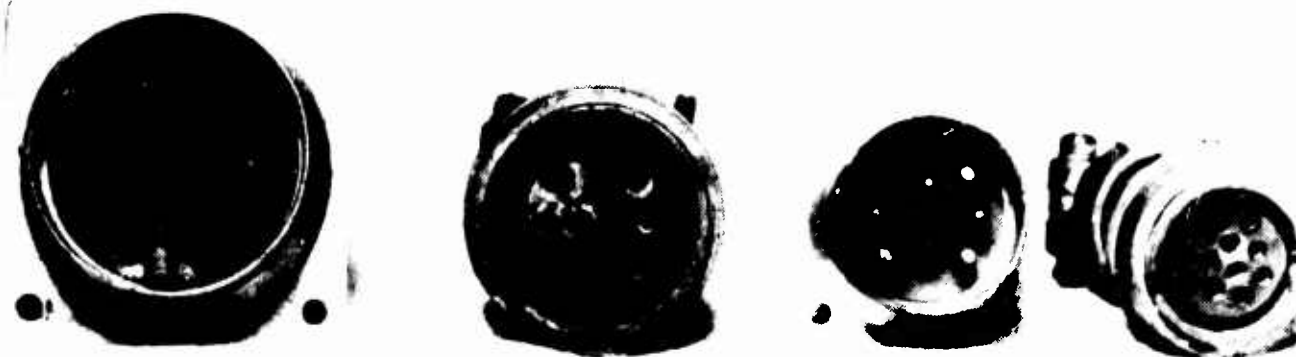
As mentioned previously, the majority of the malfunctions associated with the *SEALAB* project were attributed to connector failure associated with these sea cables. Figures 14, 15, and 16 show various degrees of corrosion and contamination which was observed on these connectors after recovery. In most cases, specific troubles can be traced to a particular connector-pin combination where the corrosion is severe. The cause of this corrosion is unknown; however, three hypotheses are offered:

- (1) Direct contact with sea water sometime during the handling process.
- (2) Pin-to-pin arcing or electrolysis while the connectors were still in the alcohol fluid.
- (3) High ambient humidity and possible salt water splash in the environment near the *SEALAB* trunk.

Figure 14. Connector corrosion and contamination

Figure 15. Connector corrosion and contamination

Figure 16. Connector corrosion and contamination

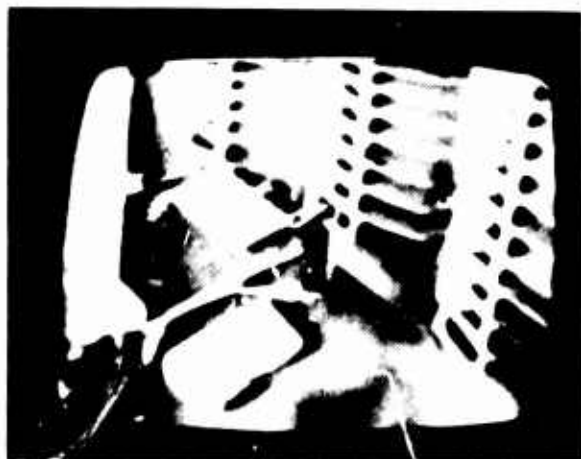
Considerable difficulty was experienced in replacing the card in the bottom slot. Visibility conditions were quite poor in that the lighting at the bottom of the module was inadequate for a sharp TV display (Figure 28) and the use of only one camera made it very difficult to estimate distances or orientation of the card at the bottom of the module. A number of tries were required before the card was finally engaged in the slot. Although an accurate measurement of time was not kept on this operation, insertion of the card

Figure 28. Manipulator in position to engage bottom card of Module 3

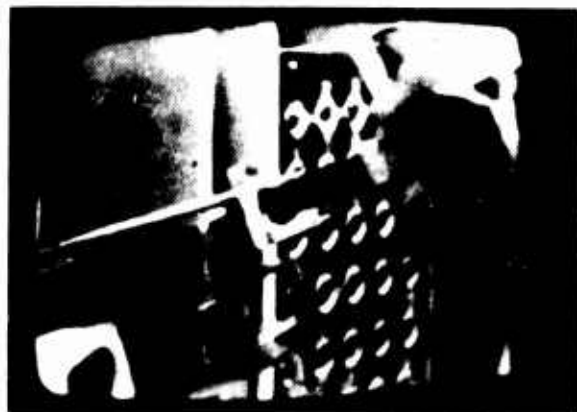
in this slot required about 20 minutes compared to the two or three minutes required for inserting the faulty card in the top slot of module 11 where visibility conditions were ideal (Figure 29). The card was successfully inserted and homed in place to full-pin contact by the manipulator and the A to D converter card reinstalled in the SEALAB rack. The data transmission link was then found to be operating satisfactorily.

Figure 29. Manipulator in position to engage top card in Module 11
